SNOW HOLLOW DAM  
IRON COUNTY, MISSOURI

MISSOURI INVENTORY NO. 30337

PHASE I INSPECTION REPORT  
NATIONAL DAM SAFETY PROGRAM

SEPTEMBER 1978

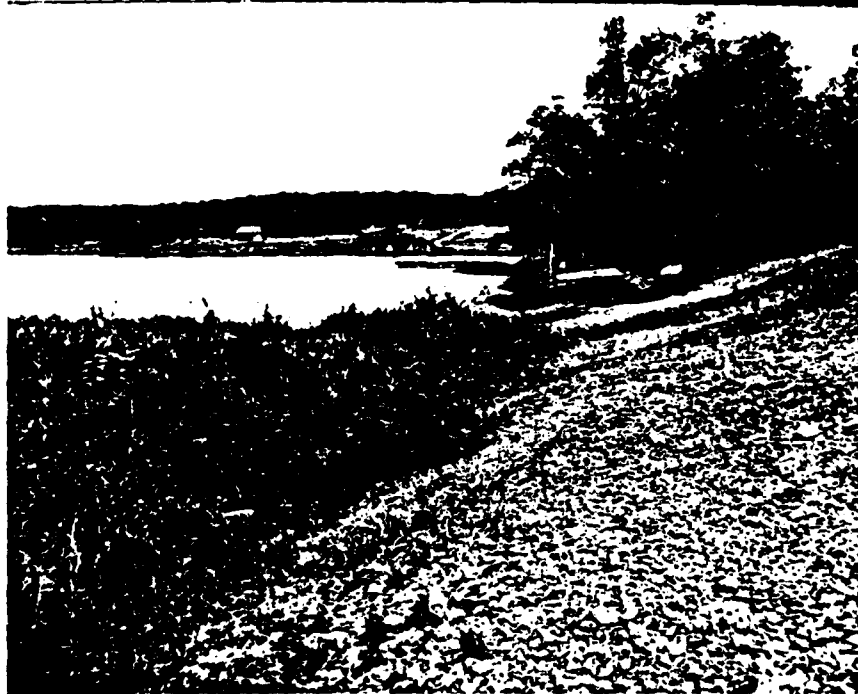
a. Description of Dam and Appurtenances: The dam is an earthfill dam with two spillways cut into the rock formations on the right and left abutments (see PHOTOS 1 and 2). The right spillway is the primary overflow exit channel. The left spillway is not as deep as the right spillway and is considered an emergency overflow channel. The lake is formed by five springs which produce flows reported to be 25,000 gallons per day. A primary portion of the drainage area for this lake is heavily wooded except for approximately 100 acres on the north and east sides of the lake which have been subdivided into lots with approximately 40 homes and cabins occupied on a full or part-time basis.

PHOTO 2: Emergency Spillway - Left Abutment

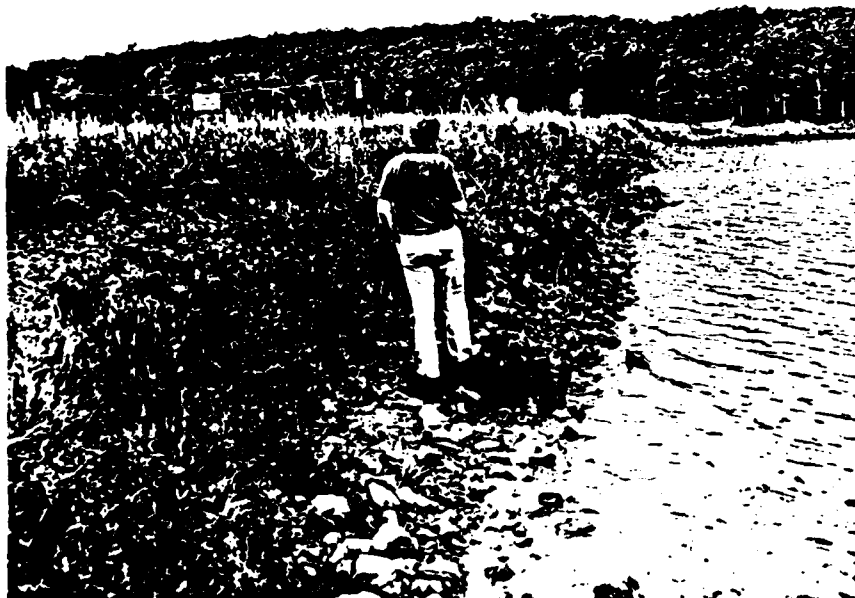
- (4) Above the waterline, upstream slopes had no riprap protection and were quite steep (see PLATE 2 and PHOTO 4). Below the waterline, slopes appeared to be much flatter and were covered with rock and/or gravel.

Provision of graded riprap on the upstream face of the dam is considered good engineering practice; however, the absence of existing wave erosion indicates the lack of riprap at this location is not of concern.

(1) Steep unprotected slopes above the waterline on the upstream face of the dam and on the inside (northeast) wall of the right spillway exit channel.

PHOTO 4: Upstream Slope of Dam

b. Provide erosion protection for the upstream slope above the waterline and on the inside (northeast) wall of the right spillway exit channel.

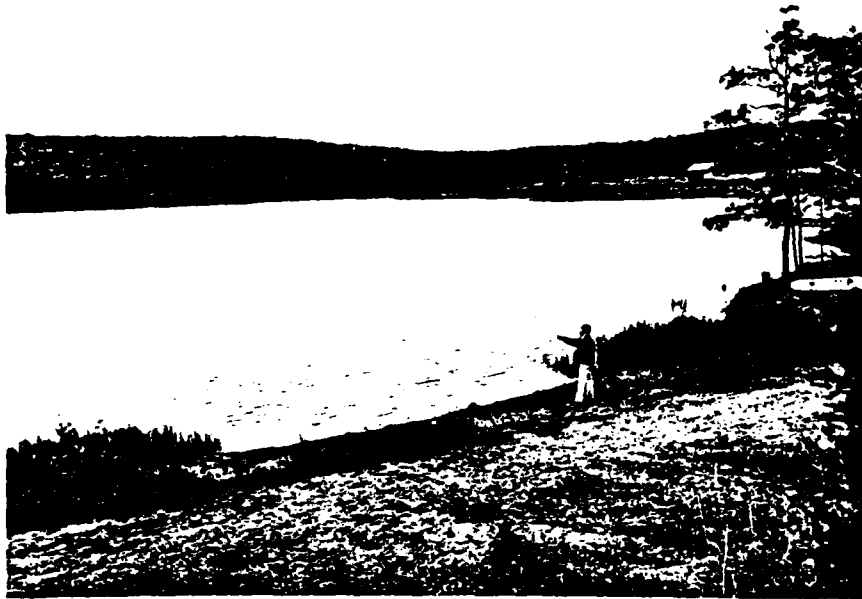
e. Reservoir Area: The shoreline around the lake is gently sloping and no excessive erosion was observed. Many rock outcroppings which appear to be grey granite could be seen along the shoreline (see PHOTOS 7 and 8).

PHOTO 7: Lake Shoreline

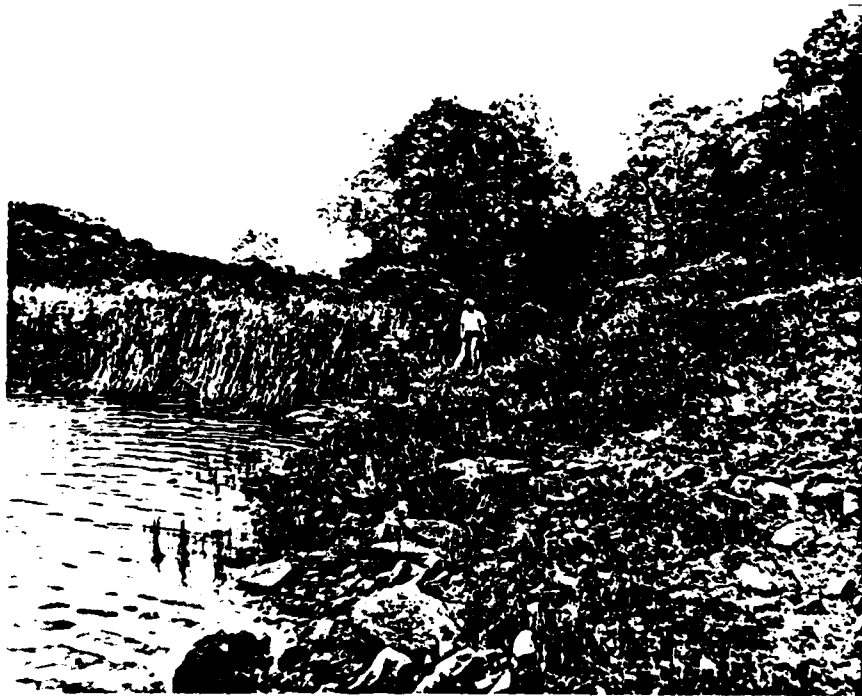
PHOTO 8: Rock Outcroppings Around Lake
